CITY OF BALTIMORE SMOKE TESTING OBSERVATION SUMMARY JONES FALLS SEWERSHED

BALTIMORE CITY PROJECT 994 REI/DRAYCO

Unique Test ID: 379 Date: 07/16/2008 Basin: JF-19

Defect No: OB01-01 Supervisor: E.R. Dye Test Recommended: N

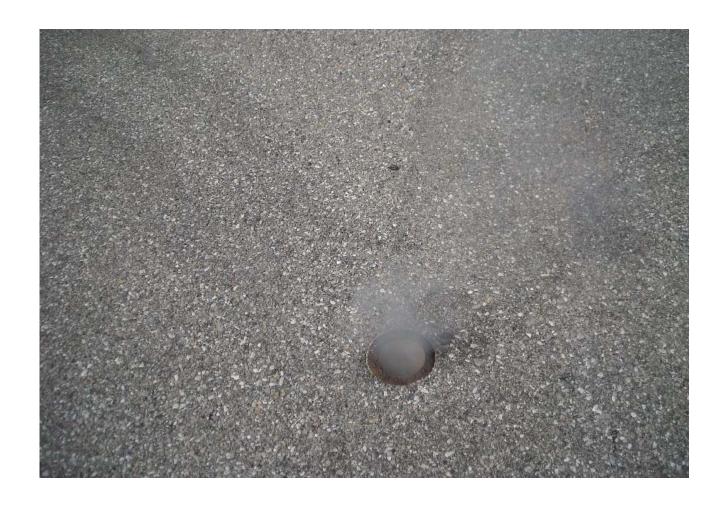
Photograph No: OB01-01 Filename: 0994-379_OB01-01.jpg

Address: 242 W. 29TH ST.

Source Type: 03 Location: 02 Severity: 03

Comments: CLEAN OUT - NO CAP - MIDDLE OF PARKING LOT OF POLICE DEPT BUILDING
